15-INCH AND 24-INCH PROPERTY LINE STORM PIPES CLEANUP WORK PLAN

STORMWATER SOURCE CONTROL IMPLEMENTATION LOWER DUWAMISH WATERWAY, SEATTLE, WASHINGTON

U.S. Environmental Protection Agency, Region 10

Anchor QEA, LLC, and Floyd | Snider

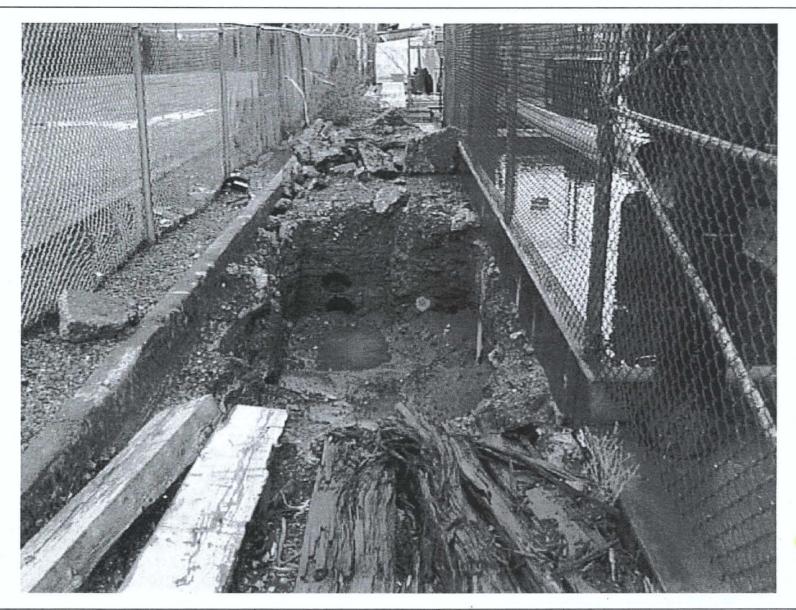
Photo A.1 Photo Taken on 12/13/01 Showing Area of Discovery Excavation Looking Towards River
